A brief assessment of trail impacts on the Witches trail Fort William as part of the UCI MTB World cup May 2006

Karl Bartlett
Forestry Commission Scotland Cycling Development Officer
June 06

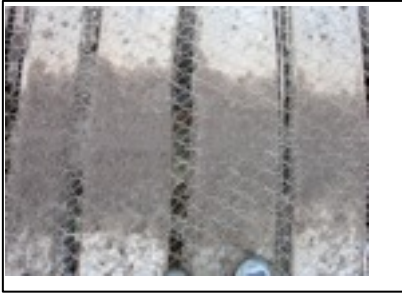
Quadrat 6 very large scale erosion, a steep section immediately above the quadrat had lost a lot of material vertically and laterally, a previously clean boardwalk was now up to 88mm deep in displaced material, an obvious visible root above the quadrat (marked as a hazard by the marshal) had all but been covered and lost.

Boardwalk section prior to race

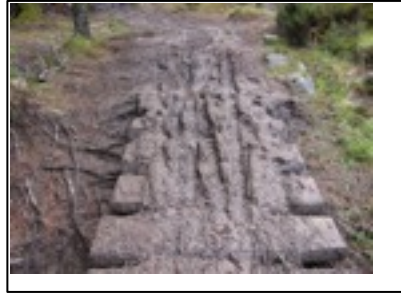
Carried on mud after 1000 bikes

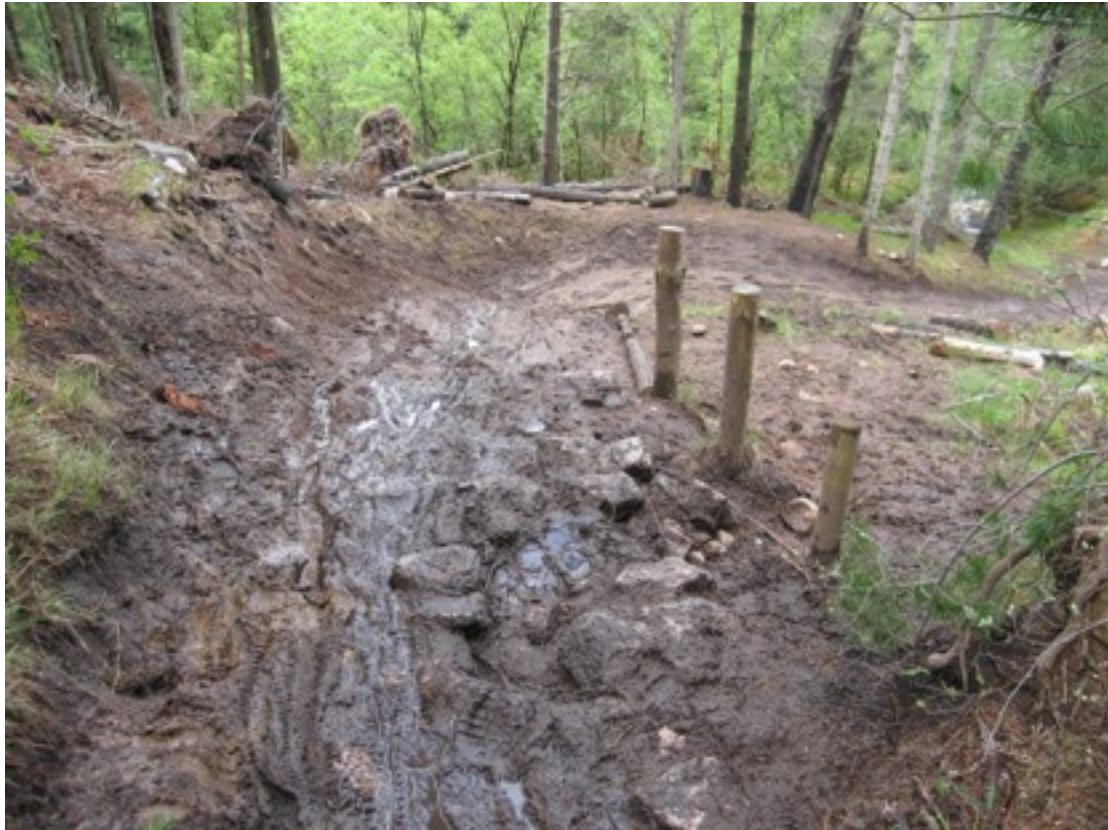
fig 1. "blue crane" 2006 showing further and continual erosion

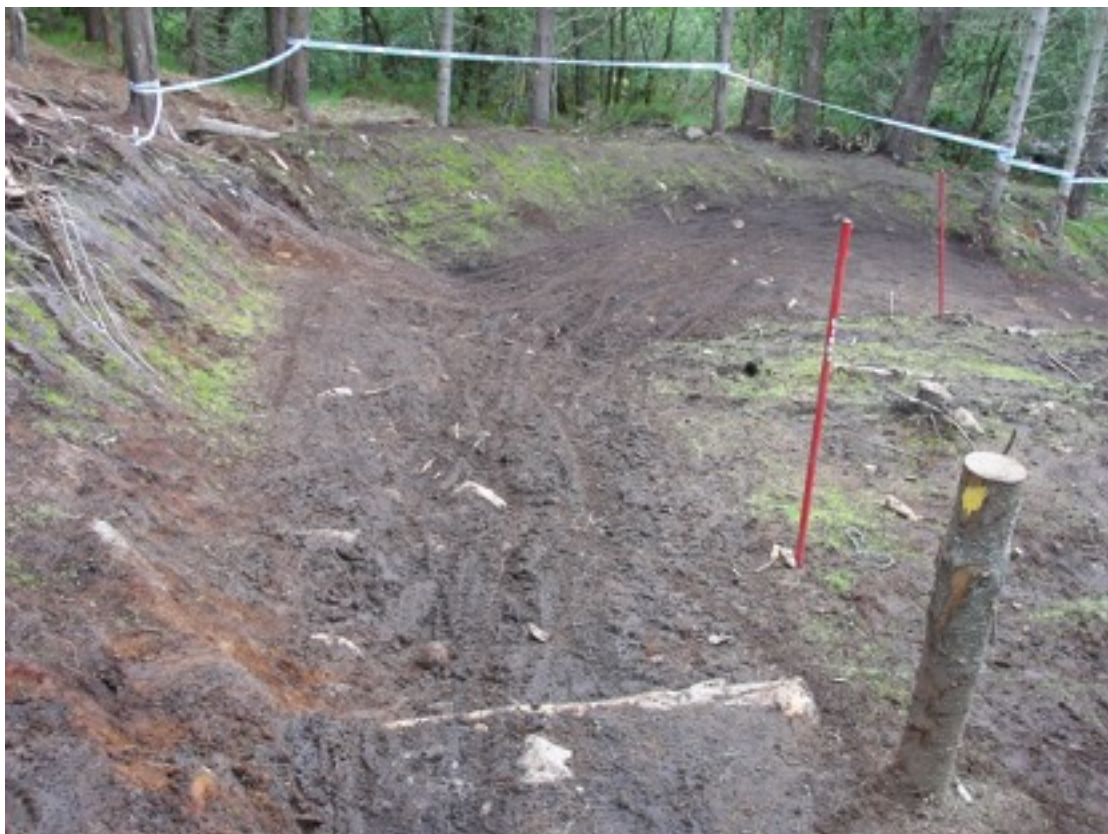
fig 2. The same trail "blue crane" in 2004

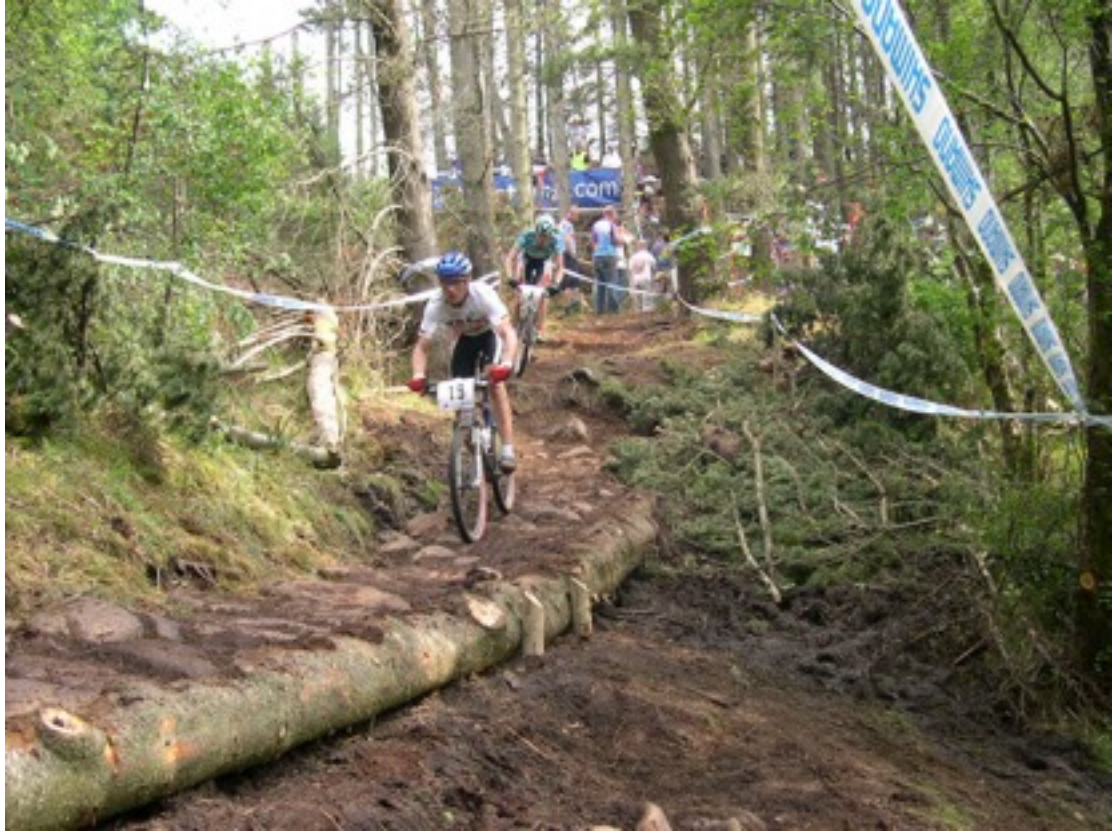
fig 3. the same trail section looking up in 2003
